September 1984
Final Report

DOT HS 806 666

AIRBAG DEMONSTRATION PROGRAM
PHASE III

13. Type of Report and Period Covered Final April - August, 1984	
		14. Sponsoring Agency Code	
		15. Supplementary Notes	
16. Abstract <u>Abstract</u> Driving and Barrier Tests were performed to determine acceleration levels required to cause an accidental deployment of a Romeo-Kojyo airbag system and a Breed Corporation Mechanical Airbag System sensor.

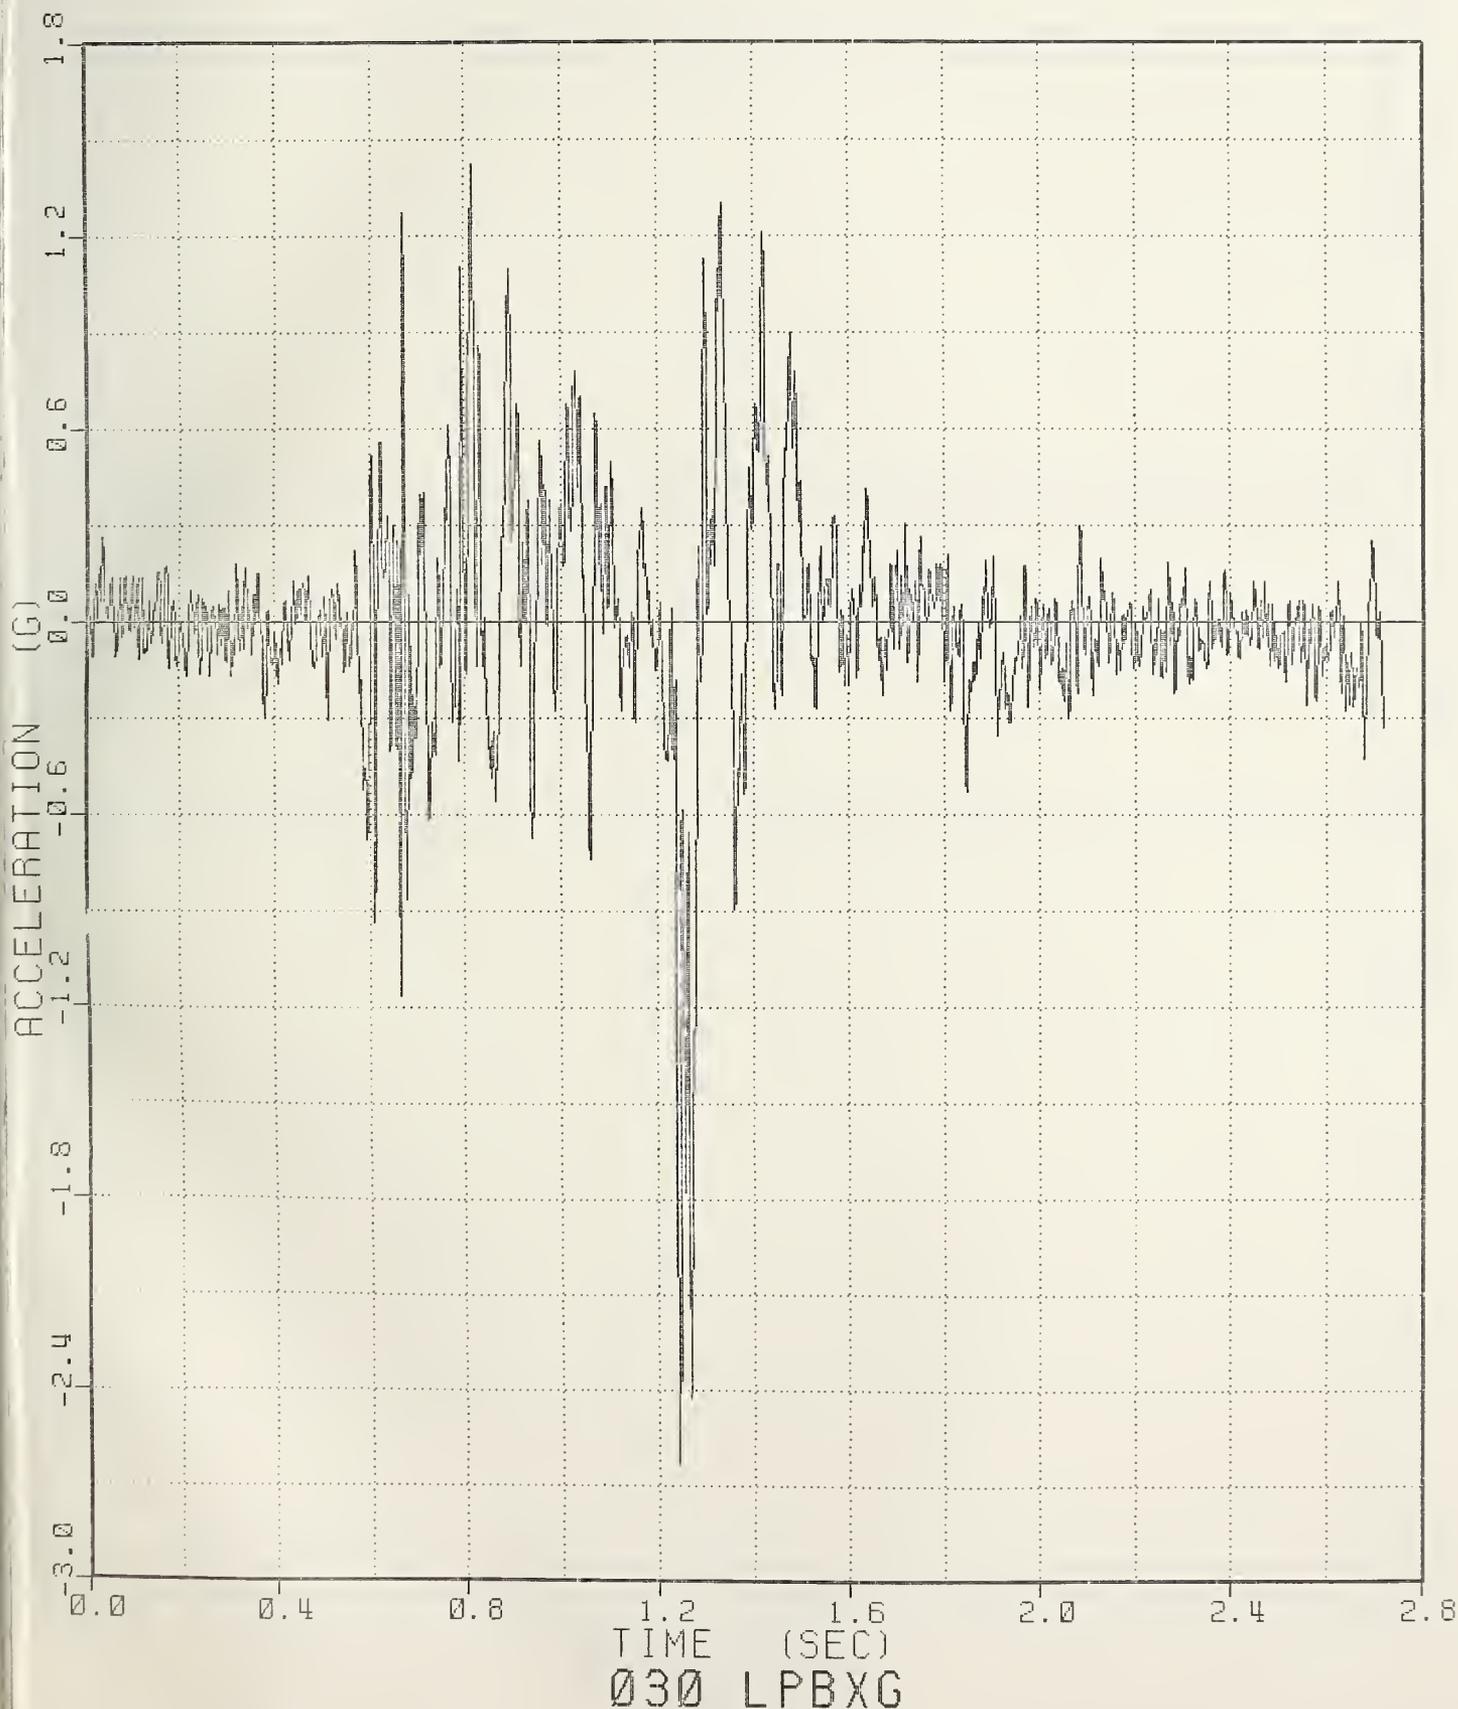
LPBXG - Acceleration in the X axis at the left B-pillar.

030ZF RD5B3-2 TST030 84171083915 28-AUG-84 16:06:36
LPBXG FILTER = BLPP 100/ 316/ -40 0.0 MPH
MIN, MAX VALUES = -2.63654 0 1.2448 1.42384 0 0.8160

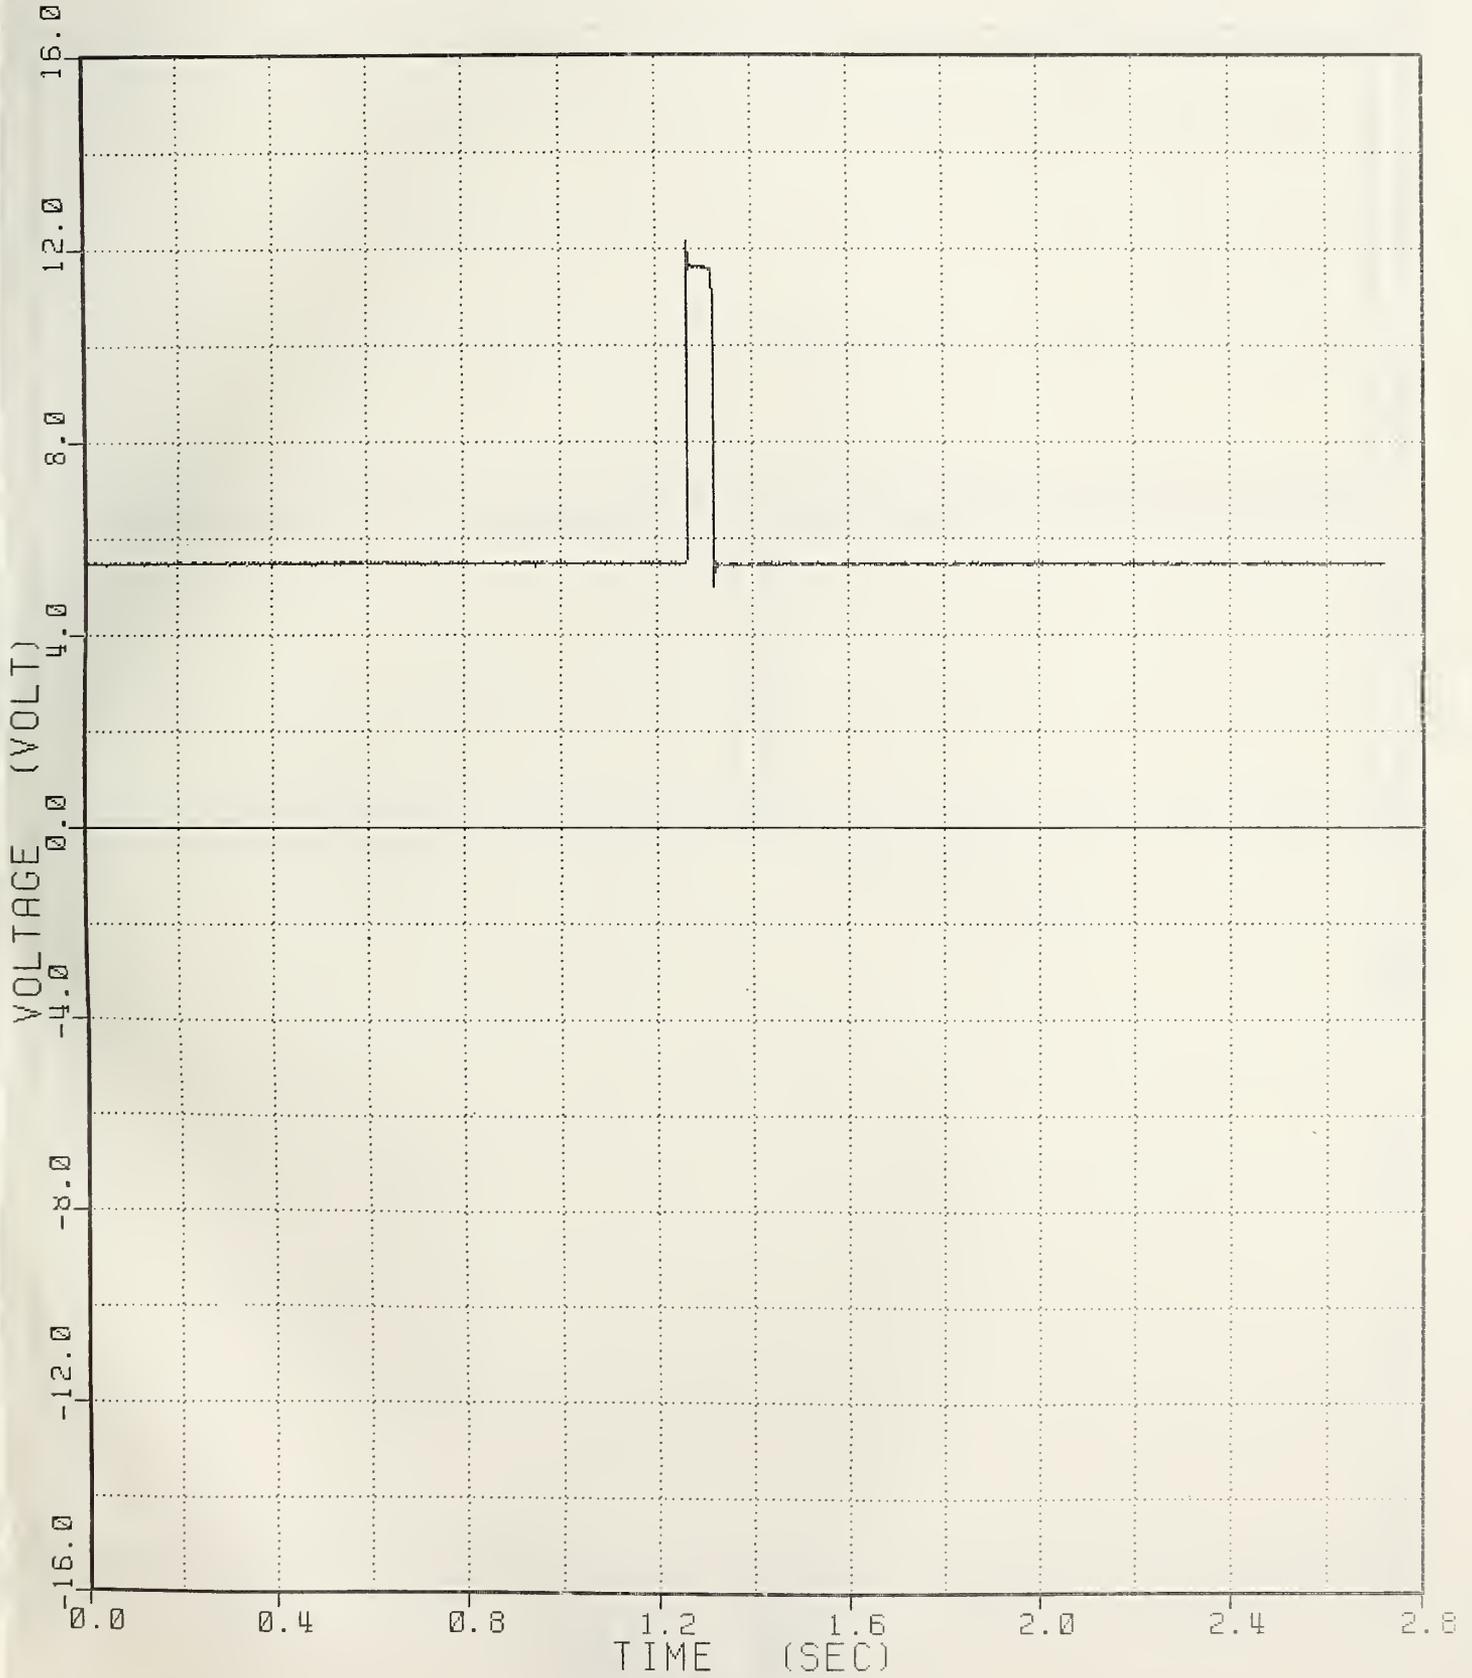
030 V2RF

V2RF - Switch closure monitor for the right front firing sensor.
